TECHNICAL REPORT REMR-CO-3

**CASE HISTORIES OF CORPS BREAKWATER
AND JETTY STRUCTURES**

**Report 2
SOUTH ATLANTIC DIVISION**

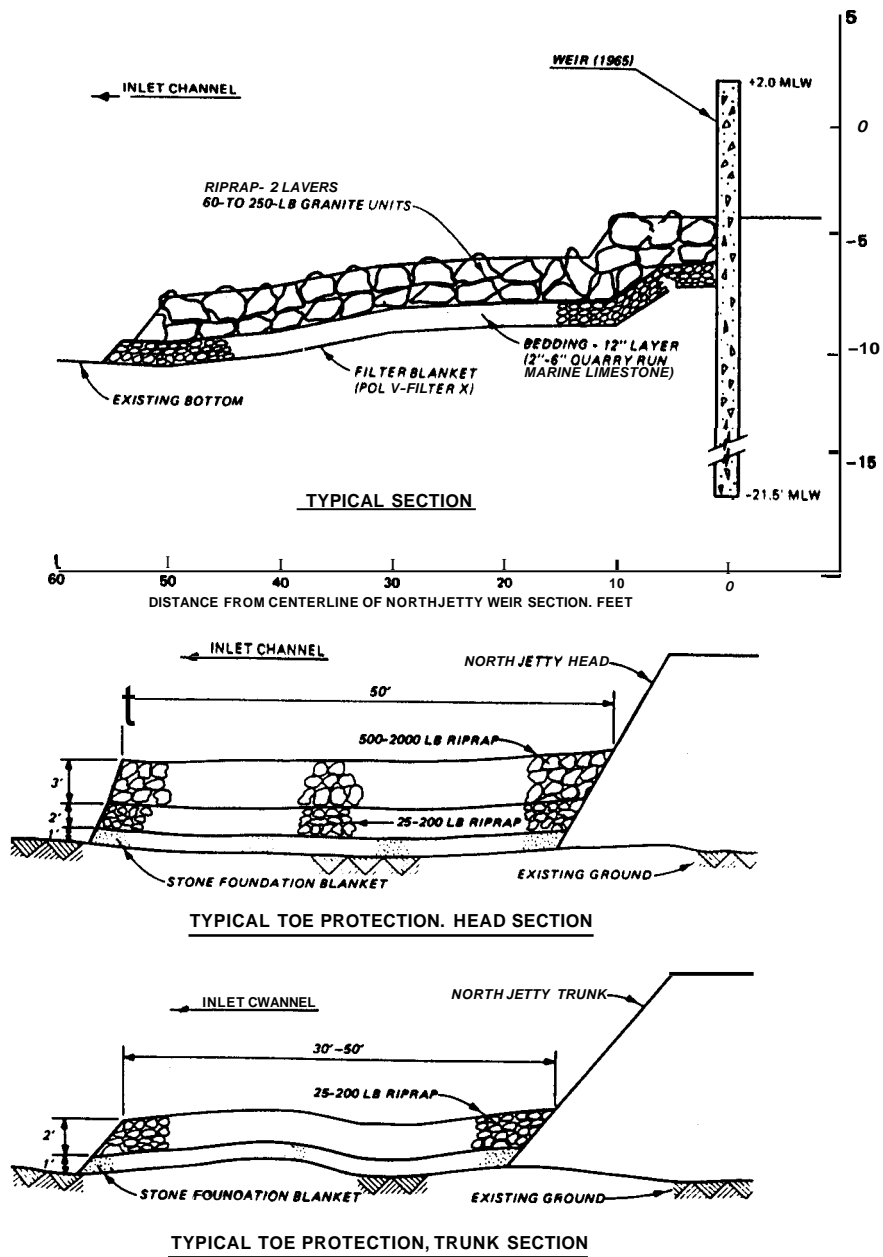
Figure 12. North jetty toe protection
Masonboro Inlet

1973- 1974	<p>Toe protection (Figure 12) was placed along the channel side of the 1,100-ft weir section because of continued movement of the navigation channel and the costs involved should a catastrophic failure occur (loss of sheet-pile sections resulting from scour and undermining). The toe apron was to be 50 ft wide with a 1-ft-thick foundation blanket of 2- to 6-in. stone overlain with a 2.5-ft layer of 25- to 250-lb riprap. Total cost of the repair was \$248,800.</p>
1978- 1980	<p>Construction of the south jetty, built of quarry stone and concrete sheet pile to a length of 3,450 ft, began in July 1978 and was completed in August 1980. A bathymetric survey taken in 1978 showed the channel to be extremely close to the north jetty with water depths up to -25 ft mhw along the rubble-mound section and -12 ft mhw along the weir jetty section. Model tests of the south jetty alignment and geometry, conducted at the US Army Engineer</p>

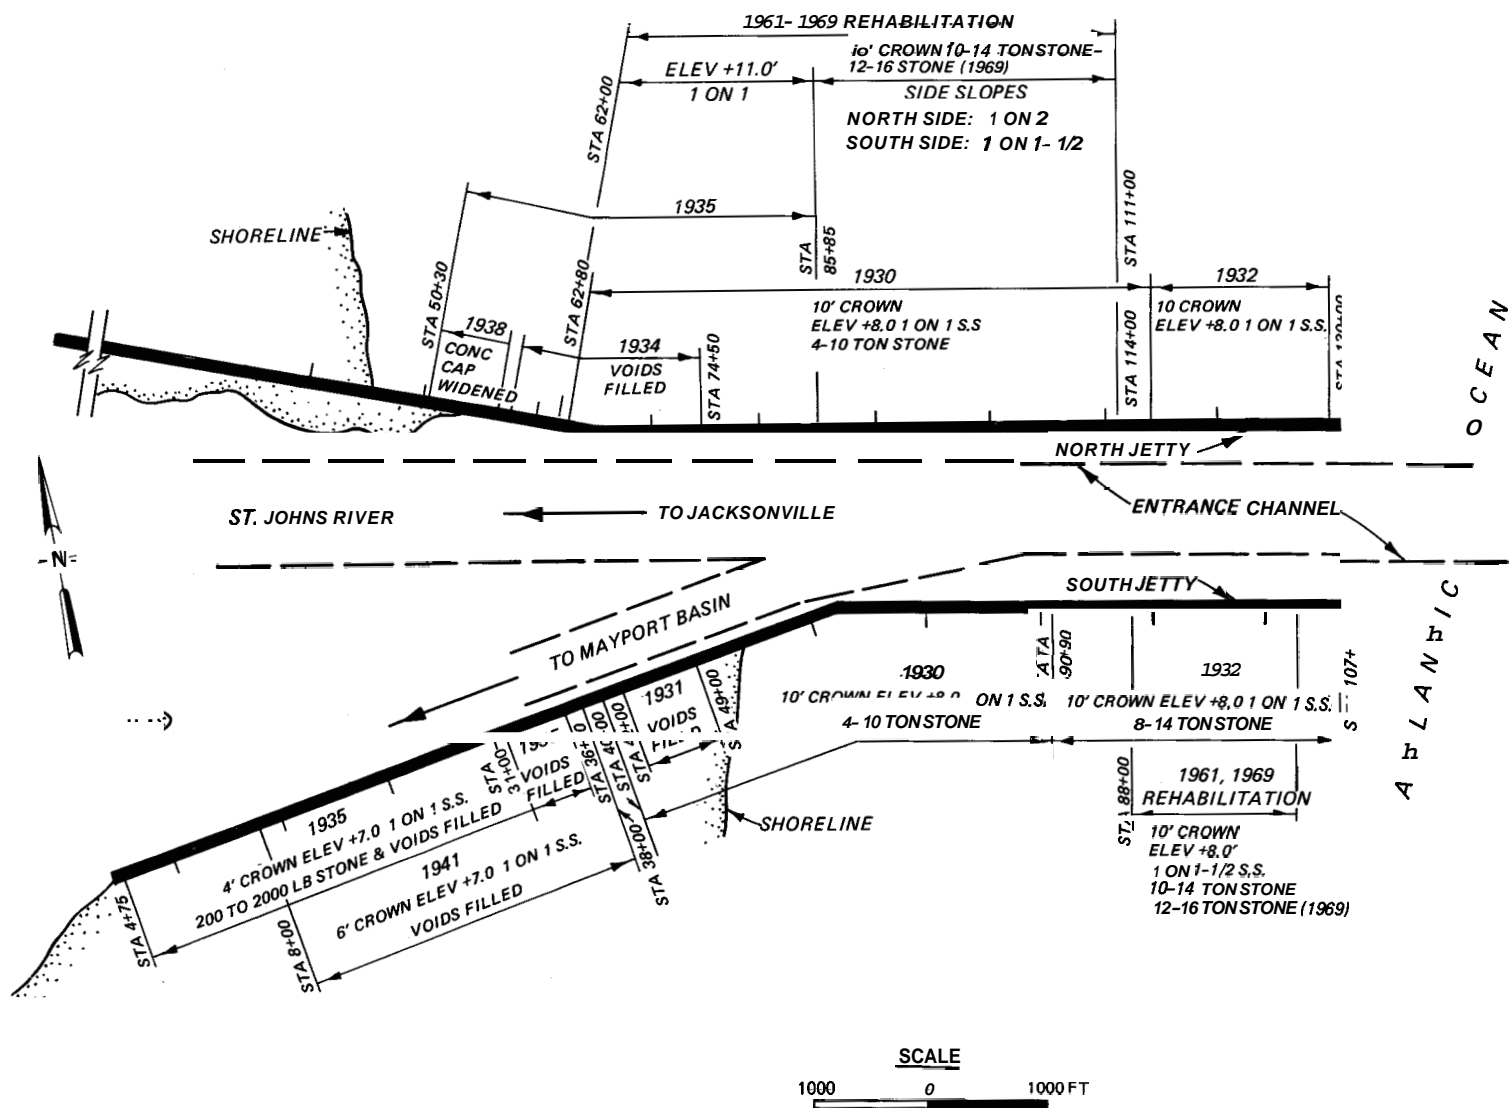
Figure 24. Plan view of cumulative repairs to Jacksonville jetties from 1930 to 1969

1930	<p>Repairs were made between sta 62+80 and 114+00 of the north jetty with 29,700 tons of granite stone (Figure 24). Nine gaps with an average height of +4 to +5 ft mlw were raised to +8 ft mlw. The crest elevations on the outer 500 ft of the jetty were from -5 to -15 ft mlw. The south jetty was repaired between sta 40+00 and 80+90 with 26,600 tons of granite (Figure 25). Twenty major gaps with average heights of +3 to +5 ft mlw were raised to +8 ft mlw. The crest elevations on the outer 700 ft of the jetty were from +3 to -10 ft mlw. The stone size was from 4 to 10 tons with an average size of 6 to 8 tons. The crown width was 10 ft, and the side slopes were 1V:1H. Cost of the repairs totaled \$228,000.</p>
1931- 1932	<p>Voids below +4 ft mlw on the ocean side of the south jetty were filled with 25- to 100-lb granite stone to stop the flow of sand through the structure, and 3,450 tons of stone were placed between sta 36+50 and 54+00 (Figure 25). A 110-ft-long groin (crest elevation +7 ft mlw) constructed of 550 tons of stone was placed at sta 44+56 on the ocean side of the south jetty to stop the flow of water along the jetty. Later, a head section on the groin was constructed using 245 tons of granite and 50 cu yd of oyster shell. Total cost of the groin was \$15,300. The seaward ends of the jetties were repaired (Figure 24), the north between sta 114+00 and 128+60 and the south between sta 88+00 and 106+30. Storm waves had, over time, lowered both jetties and created gaps, necessitating the repairs. Gaps (low points) on the jetties ranged from +3 to +4 ft mlw. The outer 500 ft of the north jetty ranged from -5 to -20 ft mlw, and the outer 700 ft of the south jetty ranged from +3 to -12 ft mlw. The armor stone ranged from 8 to 14 tons, and the design section consisted of a 10-ft crest width at +8 ft mlw and 1V:1H side slopes.</p>

1938	The north jetty concrete cap was widened from the existing 2-ft section to a width of 6 ft between sta 50+30 and 56+60 (Figure 24).
1940- 1941	Repairs were made to the south jetty between sta 8+00 and 38+00 (Figure 24). Granite stone of 1 to 3 tons and 3 to 6 tons was placed on the inner 1,200 ft and outer 1,800 ft, respectively. Void filling stone of 50 to 150 lb was placed throughout the repair section. The design called for a 6-ft crown width at +7 ft mlw with 1V:1H side slopes. Sand overlying the jetty was to be removed before stone placement. Small stone was removed between 33+00 and 38+00 as required to allow placing of the cover stone to the design section with the removed stone subsequently used to fill voids. 21,800 tons of 1- to 6-ton stone and 4,800 tons of 50- to 150-lb stone were placed at a cost \$105,000.
1961	Rehabilitation made to the seaward end of the south jetty between sta 88+00 and 102+70 and the north jetty between sta 62+00 and 11+100 (Figure 24). Areas of deterioration from settlement and dislodgement of stone had occurred at the ocean ends and along landward portions of both jetties. Also, several portions of the north jetty concrete cap had been broken and displaced from the crown along with some of the underlying support stone. The major causes of settlement seemed to be slope flattening and the possibility of wave

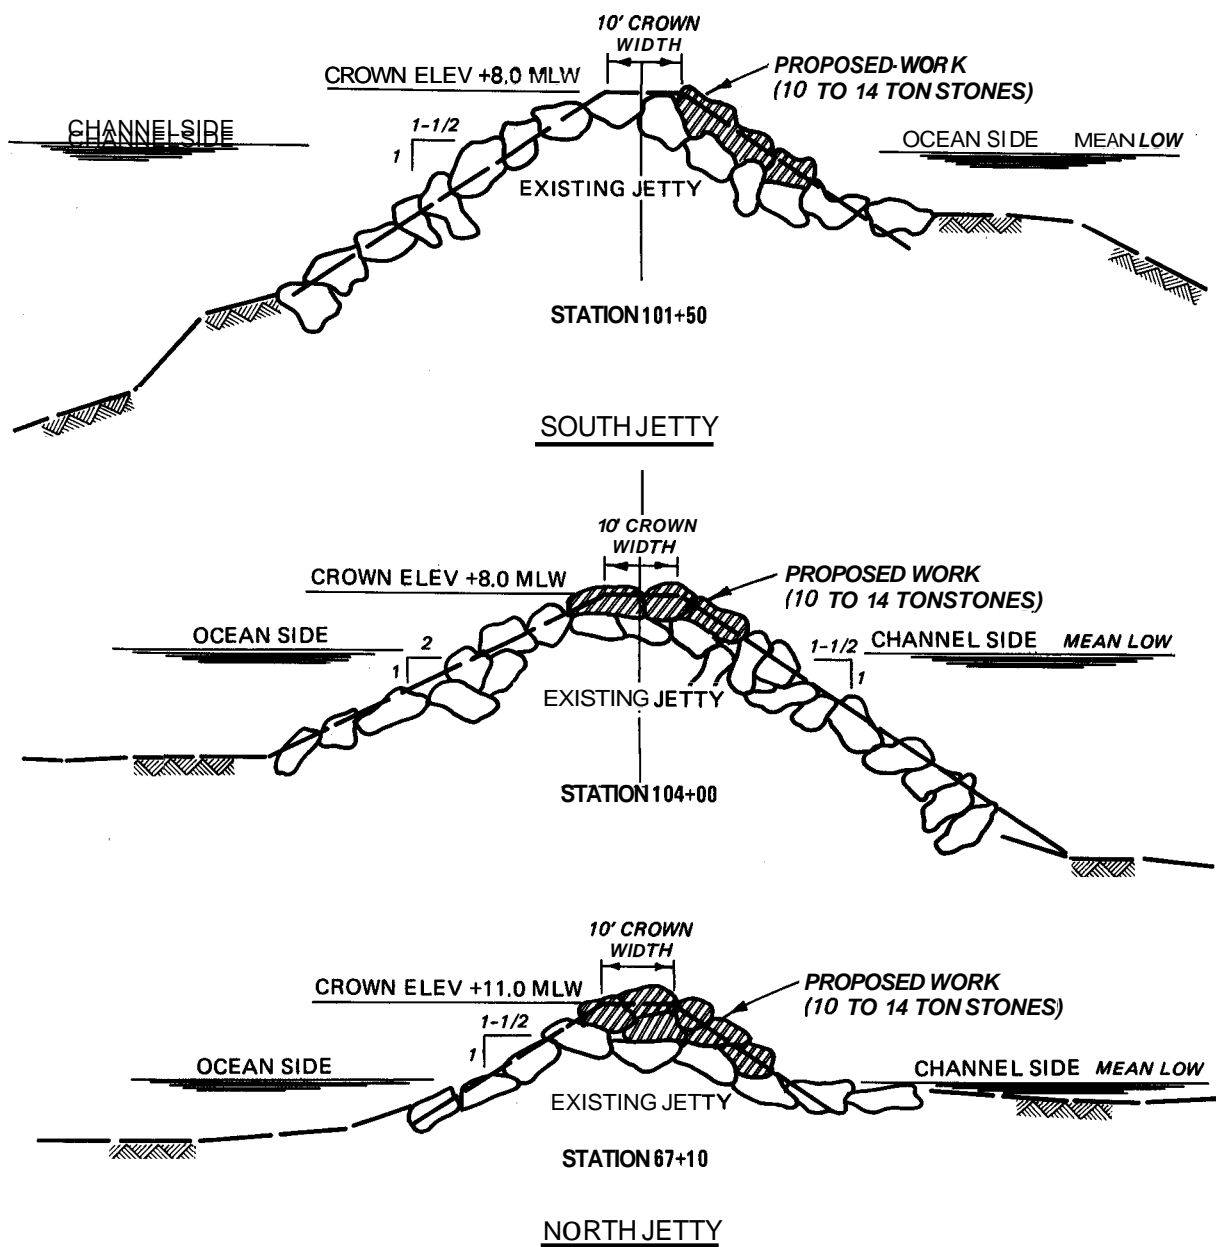
Figure 25. Typical 1961 repairs to Jacksonville jetties

Date(s)	Construction and Rehabilitation History
1961 (Cont)	<p>action causing increased consolidation. Repairs were made to bring the structure back up to previous designs but with larger stone. The design called for 10- to 14-ton granite stone and a crown width of 10 ft for all repair sections (Figure 25). On the concrete cap section of the north jetty, between 62+00 and 85+88, the crown elevation was to be +11 ft mlw, and the side slopes were 1V:1.5H. The remainder of the jetty repairs were to have a +8 ft mlw crown elevation and 1V:1.5H side slopes (with the exception of the north jetty ocean-side slope which was 1V:2H). The design was based on a 14- to 15-ft wave height and Hudson's stability equation. Cost of the rehabilitation with 5,500 tons of stone was \$54,600.</p>
1969	<p>Rehabilitation of jetties was carried out on approximately the same section as the 1961 repairs (Figure 25). Except for the use of 12- to 16-ton stone, the design sections were identical to those of 1961. The north jetty from sta 50+45 to 85+80 was built up to +11 ft mlw with 1V:1.5H side slopes and from sta 85+80 to 122+80 was built up to +8 ft mlw with 1V:2H and 1V:1.5H side slopes on the ocean and channel sides, respectively. The south jetty from sta 85+90 to 103+20 was built up to +8 ft mlw with 1V:1.5H side slopes. The crown width on all sections was 10 ft. Dislocation and consolidation of cover stone overlying smaller stone (below mlw) was thought to be the cause of jetty deterioration. The low areas to be repaired were wide which provided a good base to place new stone. Wave heights of 14 and 15 ft and Hudson's stability equation were used, similar to those in the 1961 design. A total of 21,500 tons of stone was placed at a cost of \$398,000. Inner areas of the jetties were not rehabilitated although in need of some repairs.</p>

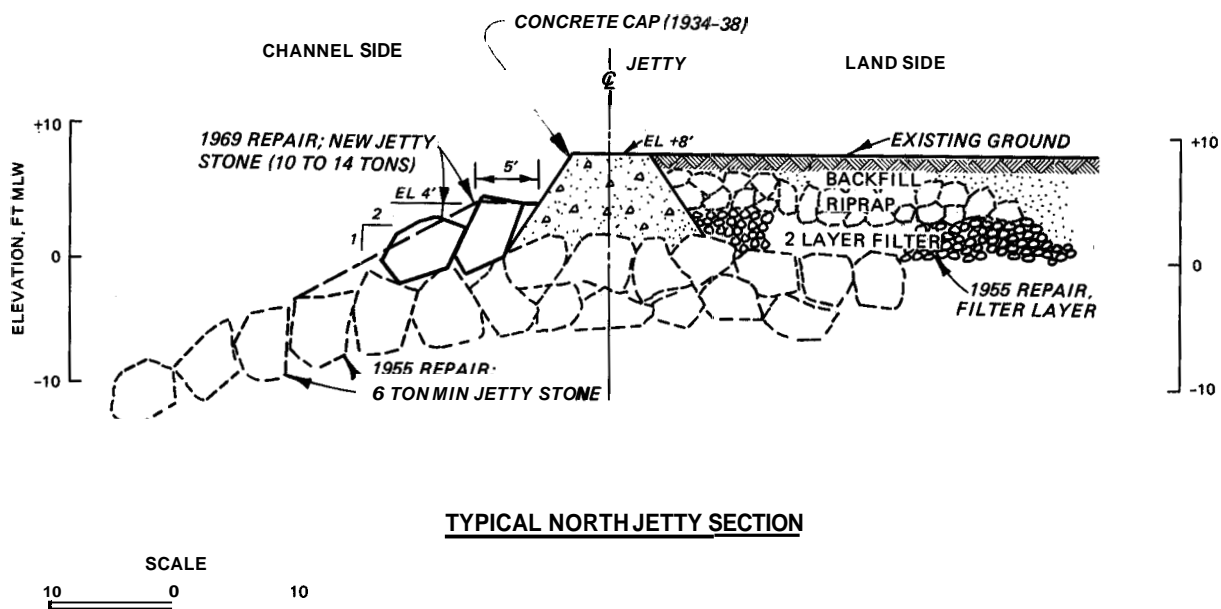
Figure 34. Palm Beach north jetty repairs of 1955 and 1969

1950	<p>In January 1950 repairs to the north jetty consisted of (a) placing a filter blanket of 1/4- to 6-in. stone along 200 ft of its shore-side landward junction (to impede sand motion) and (b) placing existing and additional 500- to 2,000-lb armor stone at the revetment/jetty cap interface (30-ft section).</p> <p>In March 1950 repair of the south jetty consisted of placing 2- to 10-ton armor stone as needed. Total cost of the repairs to the south jetty (26,000 tons of stone placed) and revetment was \$227,000. (The jetty portion was roughly 90 percent of the total.)</p> <p>In August 1950 an underwater survey of the asphalt-filled north jetty showed some deterioration on the channel side; otherwise, it continued to function properly.</p>
1955	Repairs were made to the north jetty from the existing shoreline to the landward end of the concrete cap (500 ft). A total of 1,300 tons of 6-ton minimum capstone was placed on the channel side of the repair section. Filter layers were placed on the shoreward side of the cap as follows (Figure 34): (a) 2-ft-thick lower layer of 3- to 6-in. stone placed above, and shoreward of, new/existing armor stone, (b) overlaid with 9 in. of 0.1- to 0.4-in. material, and (c) covered by a layer of 500- to 4,000-lb riprap stone. Total cost of the repairs was \$51,000.

Date(s)	Construction and Rehabilitation History
1967- 1968	The harbor was deepened to 35 ft. Federal support of the sand transfer plant ended.
1969	Rehabilitation of the 550-ft seaward section of the north jetty was made with 10- to 14-ton capstone on 1V:2H-side slopes (Figure 34). A total of 2,000 tons of armor stone was placed at a cost of \$83,000. A design wave height of 15 ft and a 14-sec wave period were used to select the capstone size.
1985	Present plans call for repairs to 1,300 ft of the south jetty. The jetty would be made impervious to sand motion via injection of silicate grout on the shoreward 800 ft and via a rubble filter on the seaward 500 ft. For slope protection, 5- to 10-ton stone were placed on 200 ft of the channel side (near shoreward end). The design wave height of 12.7 ft (obtained using the method outlined in Seelig and Ahrens (1980) used to compute size of cover stone to provide protection of the filter layer on the seaward end of repair). Cover stone will be 8 to 14 tons with an underlayer of 800- to 2,400-lb stone and 3- to 6-in. filter stone. The estimated first cost is \$2.2 million.

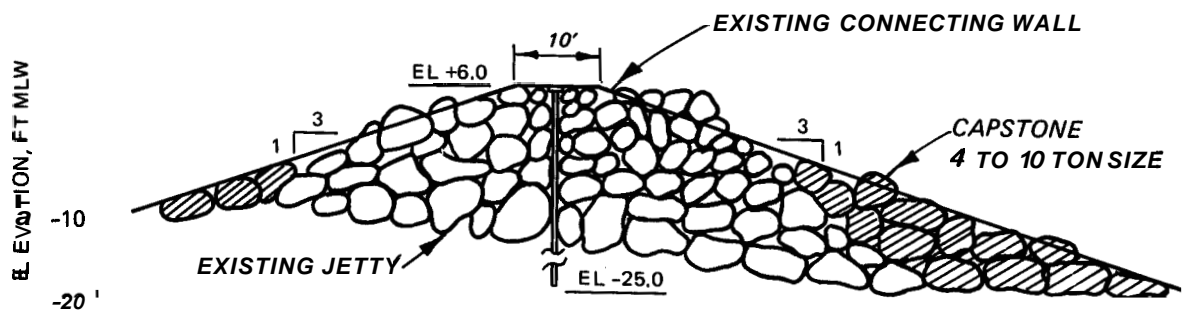
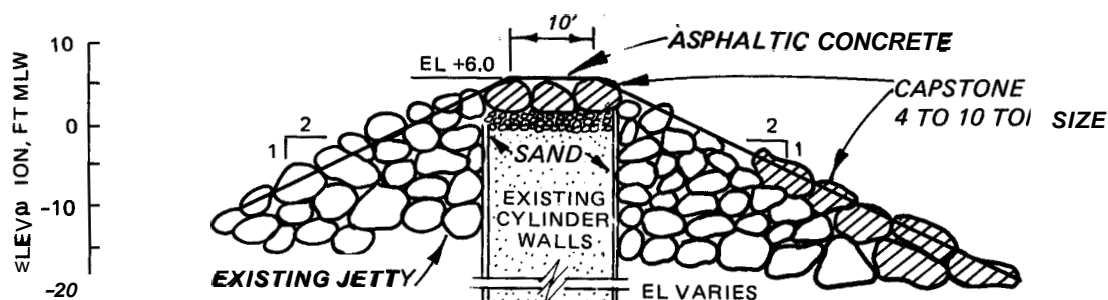
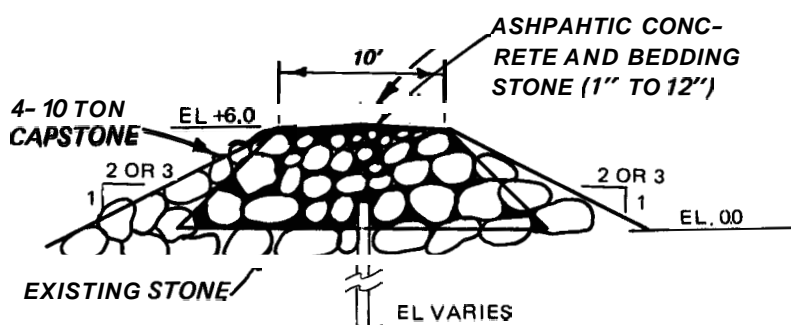
Figure 40. Typical 1969 jetty repair sections as Casey's Pass

1978	<p>Repair to jetties consisted of resetting stone and adding 6- to 12-ton stone (75 percent > 10 ton) on the outer 200 ft of the jetties and 2- to 6-ton stone on the next 450 ft of the jetties as needed to solidify the structure.</p>
1985	<p>The jetties are in good condition except for their head sections which are in need of some repair.</p>

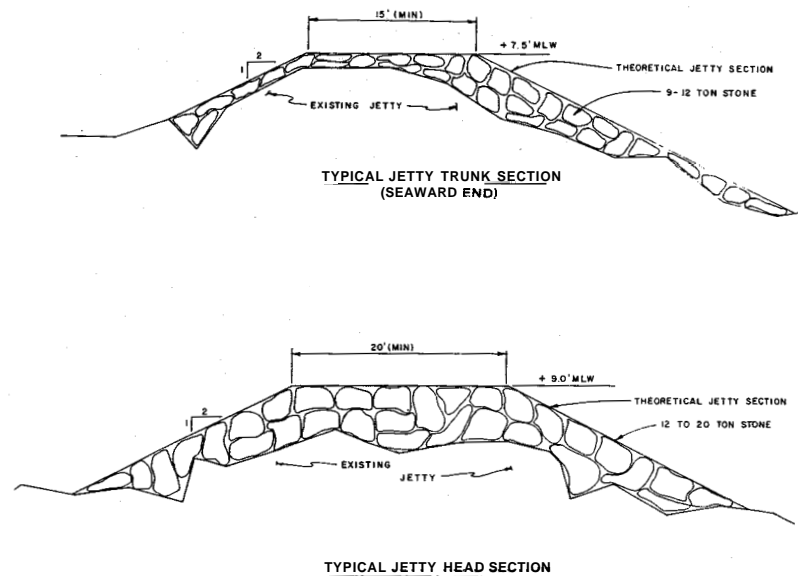
Figure 51. Typical 1984 repair sections of the east jetty at Panama City

Date(s)	Construction and Rehabilitation History
1983- 1984 (Cont)	<p>The outer 200 ft of the existing west jetty was in fair condition with an average elevation of +4.5 ft mlw, and the average water depth, seaward of the jetty, was -20 ft mlw. A scour valley extended along the toe of the west jetty head and was approximately 50 ft wide and 10 to 12 ft deep seaward of the jetty axis. The east jetty wing extension was in fair condition with an average elevation of +4.5 ft. The west jetty wing extension was in poor condition with average elevations of +3.5, +0.5, and -7.5 ft mlw along successive landward sections of 700, 450, and 400 ft (landward end). Side slopes were typically 1V:2H or less (i.e., 1V:3H). Rehabilitation of 1,060- and 1,240-ft-long seaward sections of the east and west jetties, respectively, employed 3 design cross sections (Figure 51). The inner trunk section had a +6 ft mlw crown elevation and 5- to 9-ton cover stone. The outer trunk section had a +7.5-ft mlw crown elevation and 9- to 12-ton cover stone. Both sections had 15-ft minimum crown widths. The head section had a +9 ft mlw crown elevation, 20-ft minimum crown width, and 12- to 20-ton cover stone. All sections had 1-V:2-H side slopes except the head semicircles, which were warped from 1V:2H (normal to the jetty axis) to 1V:3H (along the jetty axis). Transition sections (both in geometry and stone size) between the design sections were 100 ft long, except for the east jetty inner to outer trunk transition, which was 79 ft long. The lengths of the head, inner trunk, and outer trunk sections on the east jetty were 100, 301, and 420 ft long, respectively, and on the west jetty were 100, 300, and 500 ft long, respectively. The estimated quantity of cover stone was 21,600 tons. The rehabilitation also required removing approximately 150 ft of collapsed steel sheet-pile wall on the west jetty (beginning 1,000 ft from the seaward end) and breaking up the asphalt layer which covered sections of both jetties (from the 1938 repairs), into segments no larger than 20 sq ft. The entrance channel is presently maintained at a depth of 42 ft and a width of 450 ft. Figure 52 is an aerial view of the jetties taken prior to their rehabilitation.</p>
